WL-TR-92-3029

BIRD IMPACT RESISTANT ANALYSIS OF  
THE F-15E PRODUCTION TRANSPARENCY SYSTEM

Windshield Program Office  
Aircrew Protection Branch  
Wright-Patterson AFB OH 45433-6553

FINAL REPORT FOR 05/01/91 - 11/01/91

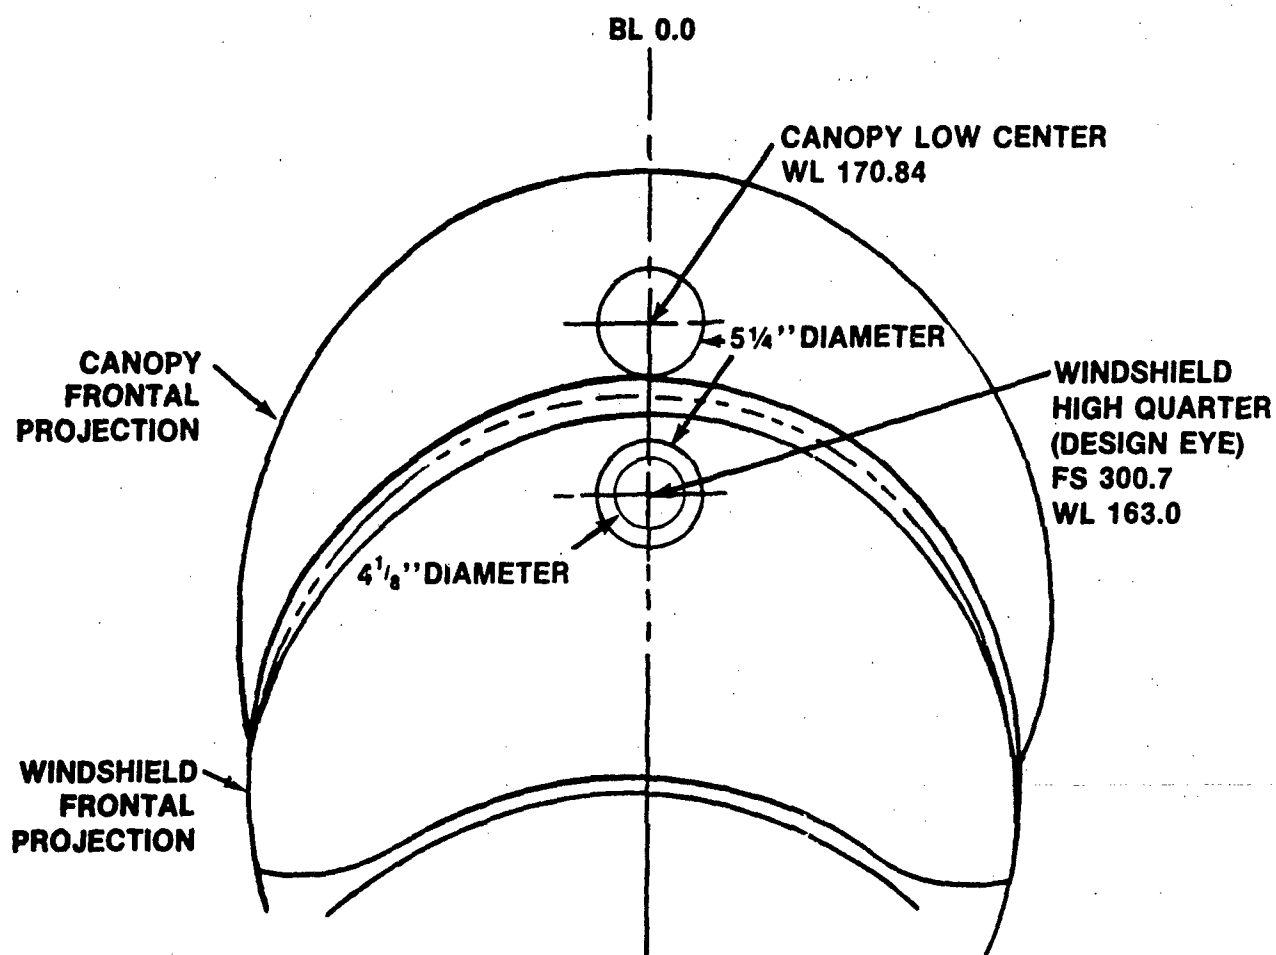
**FIGURE 4A**  
**IMPACT LOCATIONS**

**2.1 Test Article** The test article was comprised of the production windshield, PN 68A350016-1001, and canopy, PN 68A350010-1009, manufactured by McDonnell Douglas Corporation (Figure 3). A monolithic stretched acrylic windshield panel, supplied by Swedlow Incorporated, was bonded into a titanium and aluminum frame with PR 1725 polysulfide sealant. The impact locations selected for the testing consisted of the windshield center, high quarter point and the canopy low center point (Figure 4a).

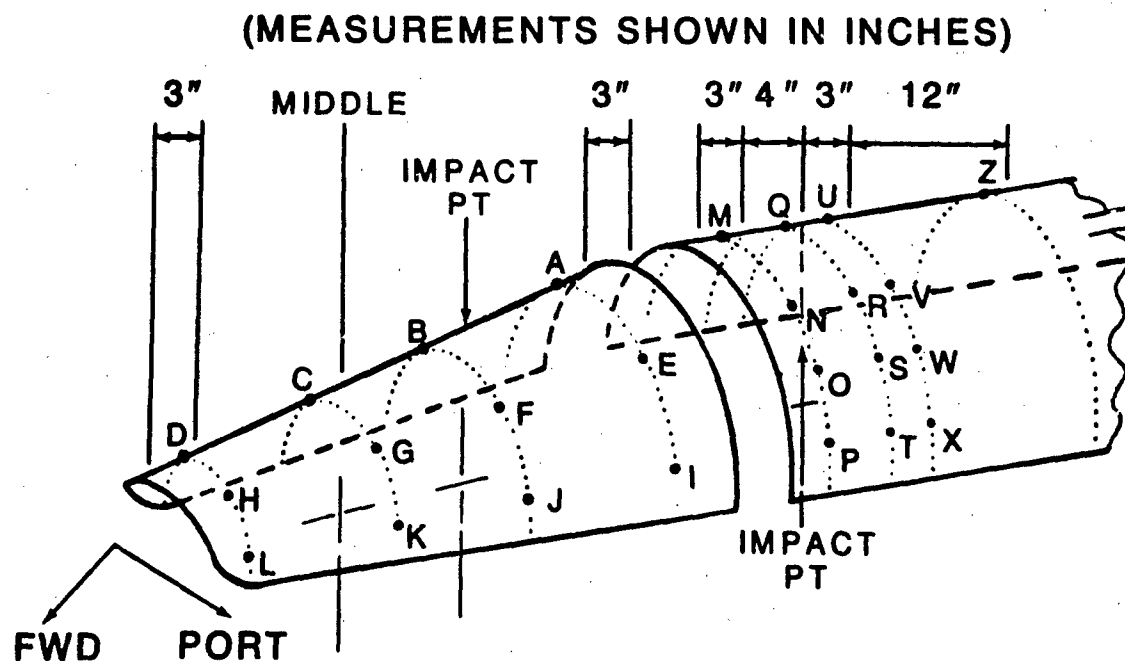
FIGURE 4B  
MEASUREMENT LOCATIONS  
AND THICKNESS VALUES

Before each test, the thickness of the acrylic panel was measured to ensure it was within the required tolerance. An ultrasonic thickness measurement instrument provided the most accurate result without degrading the acrylic. The locations at which measurements were taken on each test article as well as the corresponding thickness values are found in Figure 4b.

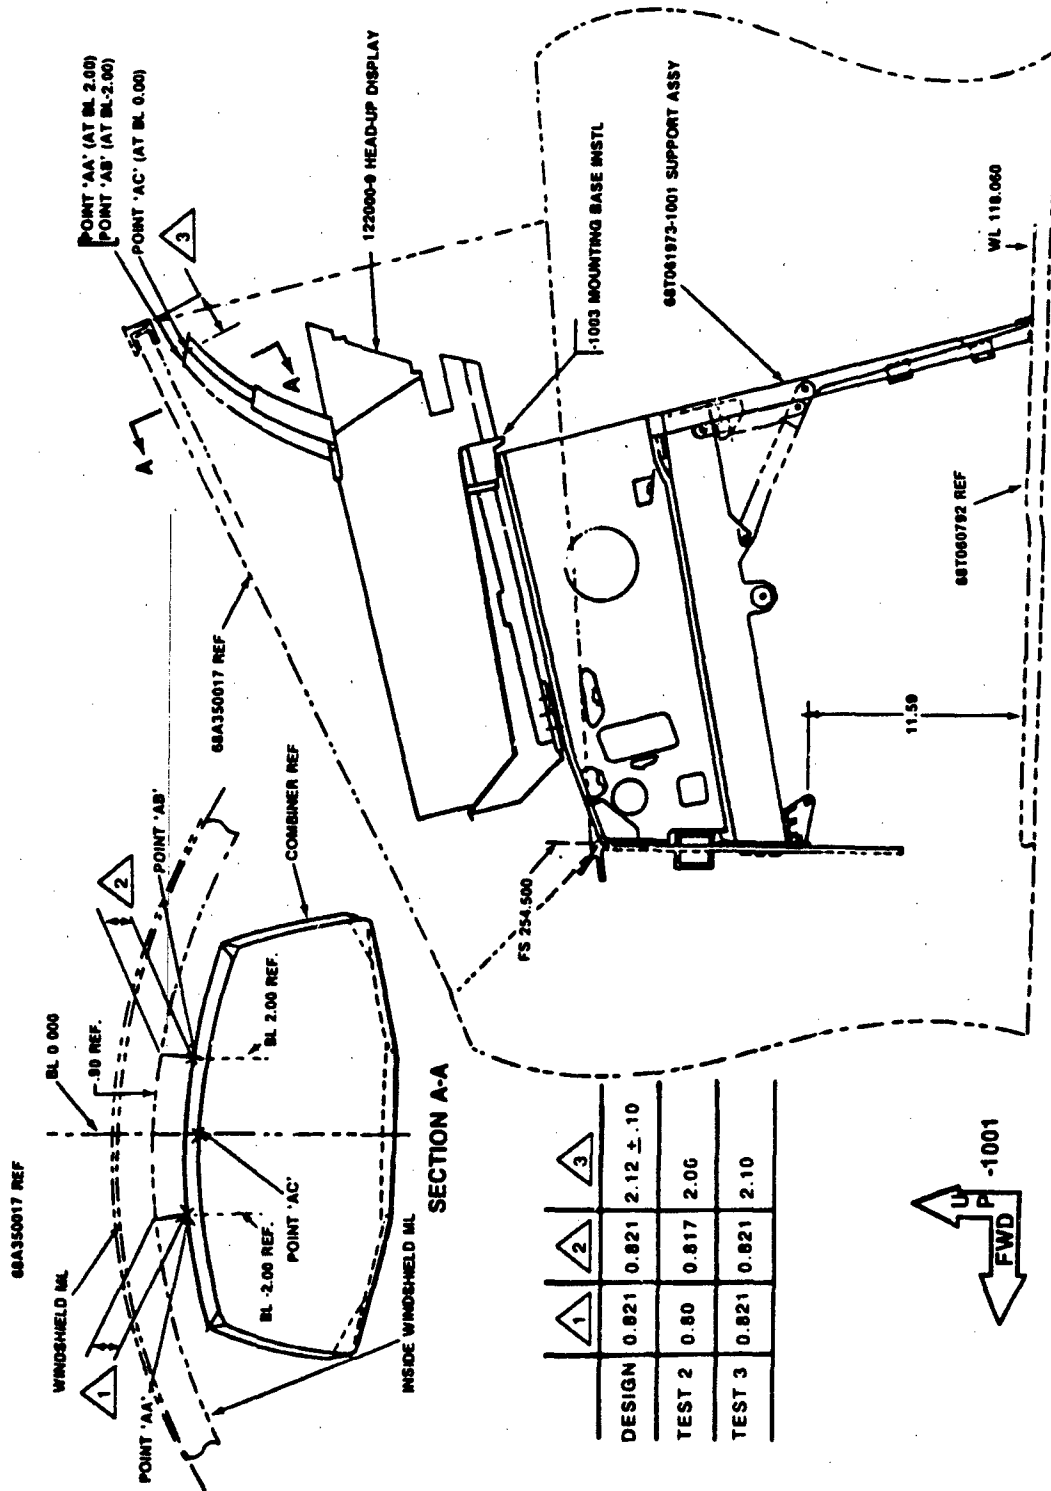
**FIGURE 5**  
**COMBINER GLASS**  
**CLEARANCES**

The first concern was that the presence of the Head Up Display (HUD) could reduce the bird impact resistance of the windshield demonstrated in the qualification testing. The F-15E HUD incorporates a wide field-of-view combiner glass with a clearance between 0.82 and 0.94 inch from the inner surface of the windshield. The HUD was not present during birdstrike Test Q3 of the qualification testing in which the windshield deflection in the HUD area was 1.24 inches (Reference 3). The resulting 0.3 inch interference at the HUD could be enough to initiate failure of the acrylic panel, thus reducing the 435 knot birdstrike resistance demonstrated at the windshield center high quarter point.

**2.2 Test Fuselage** The test series utilized the F-15 Forward Fuselage Structural Assembly that was upgraded from an F-15B to an F-15E configuration (Figure 3). A wide field-of-view HUD and an inert ACESII ejection system was installed. The HUD was mounted on the production support structure to position the combiner glass relative to the windshield in the location shown in Figure 5.
